#### COMMUNITY TREES AND FORESTRY CONSERVATION STEWARDSHIP PLAN

#### **BECKONRIDGE HOA COMMON AREA PROPERTIES**

9402 47<sup>TH</sup> ST W UNIVERSITY PLACE, WA 98466

March 27, 2025

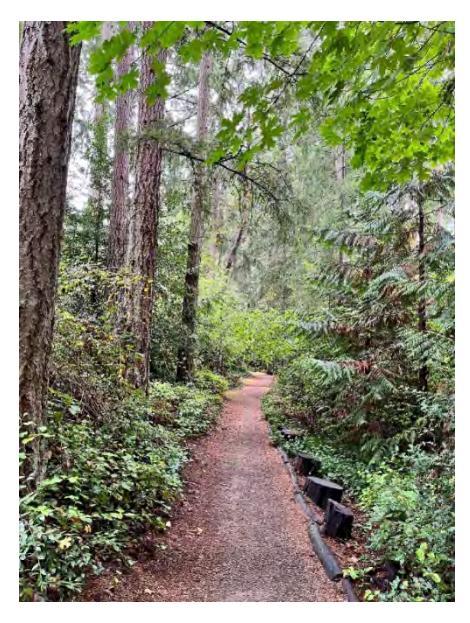
Figure 2: Typical forest with mature Douglas-fir

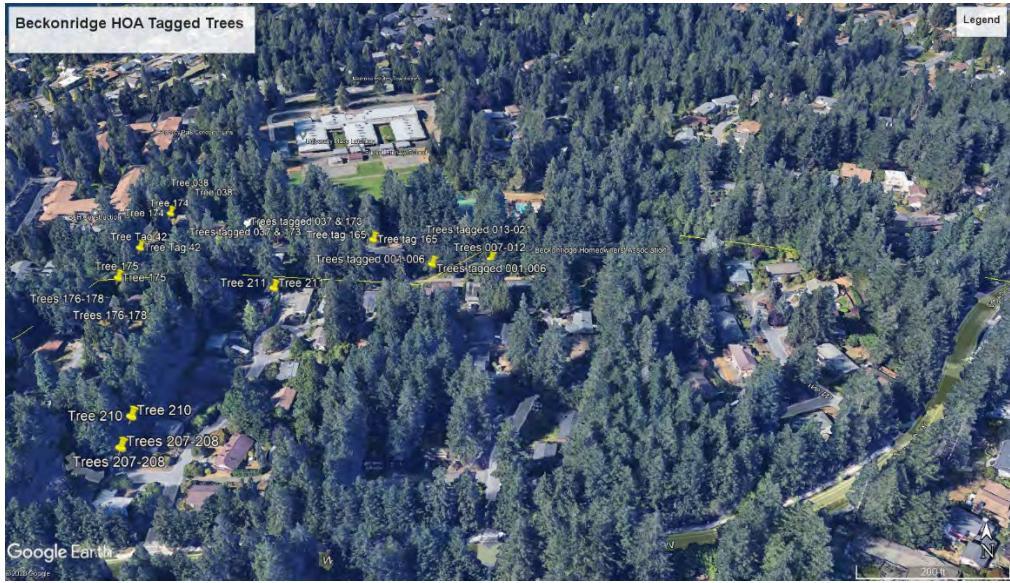
- During the Spring/Summer of 2024 a Google Earth Pro Mapping project was completed to geo-reference the GPS Latitude and Longitude of each of the 300+ tagged trees (See Figure 3).
- A Google Drive link of the HOA Tagged Trees map was provided for sharing with residents who can view via a free download Google Earth Pro

Figure 3: Example of Google Earth Beckonridge HOA Forest Areas

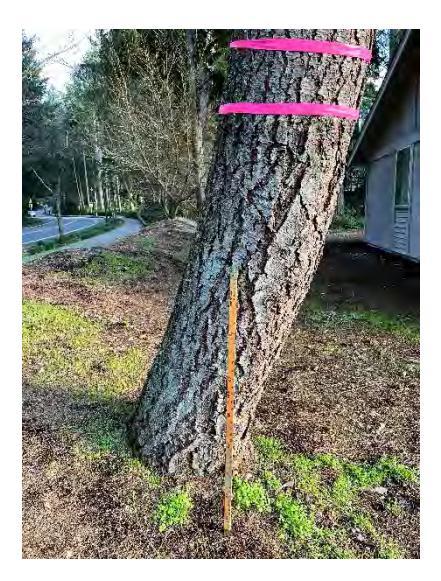
As tree and forest management work is needed, individual trees within the Block would be "tagged" with a metal tag and attached with aluminum nails (See Figure 4: Tree Tag) to the tree. The tree tag number and information would be entered into a HOA Tree Work Spreadsheet by tag number, Management Block number, Species, DbH (diameter), tree work needed (HOA Maintenance crew or contractor) and risk or priority rating. Information is then provided to the HOA Grounds and Maintenance Committee for evaluation and budgeting purposes at least annually.

Figure 4: Example of Tree Tag for ID and Pink Flagging

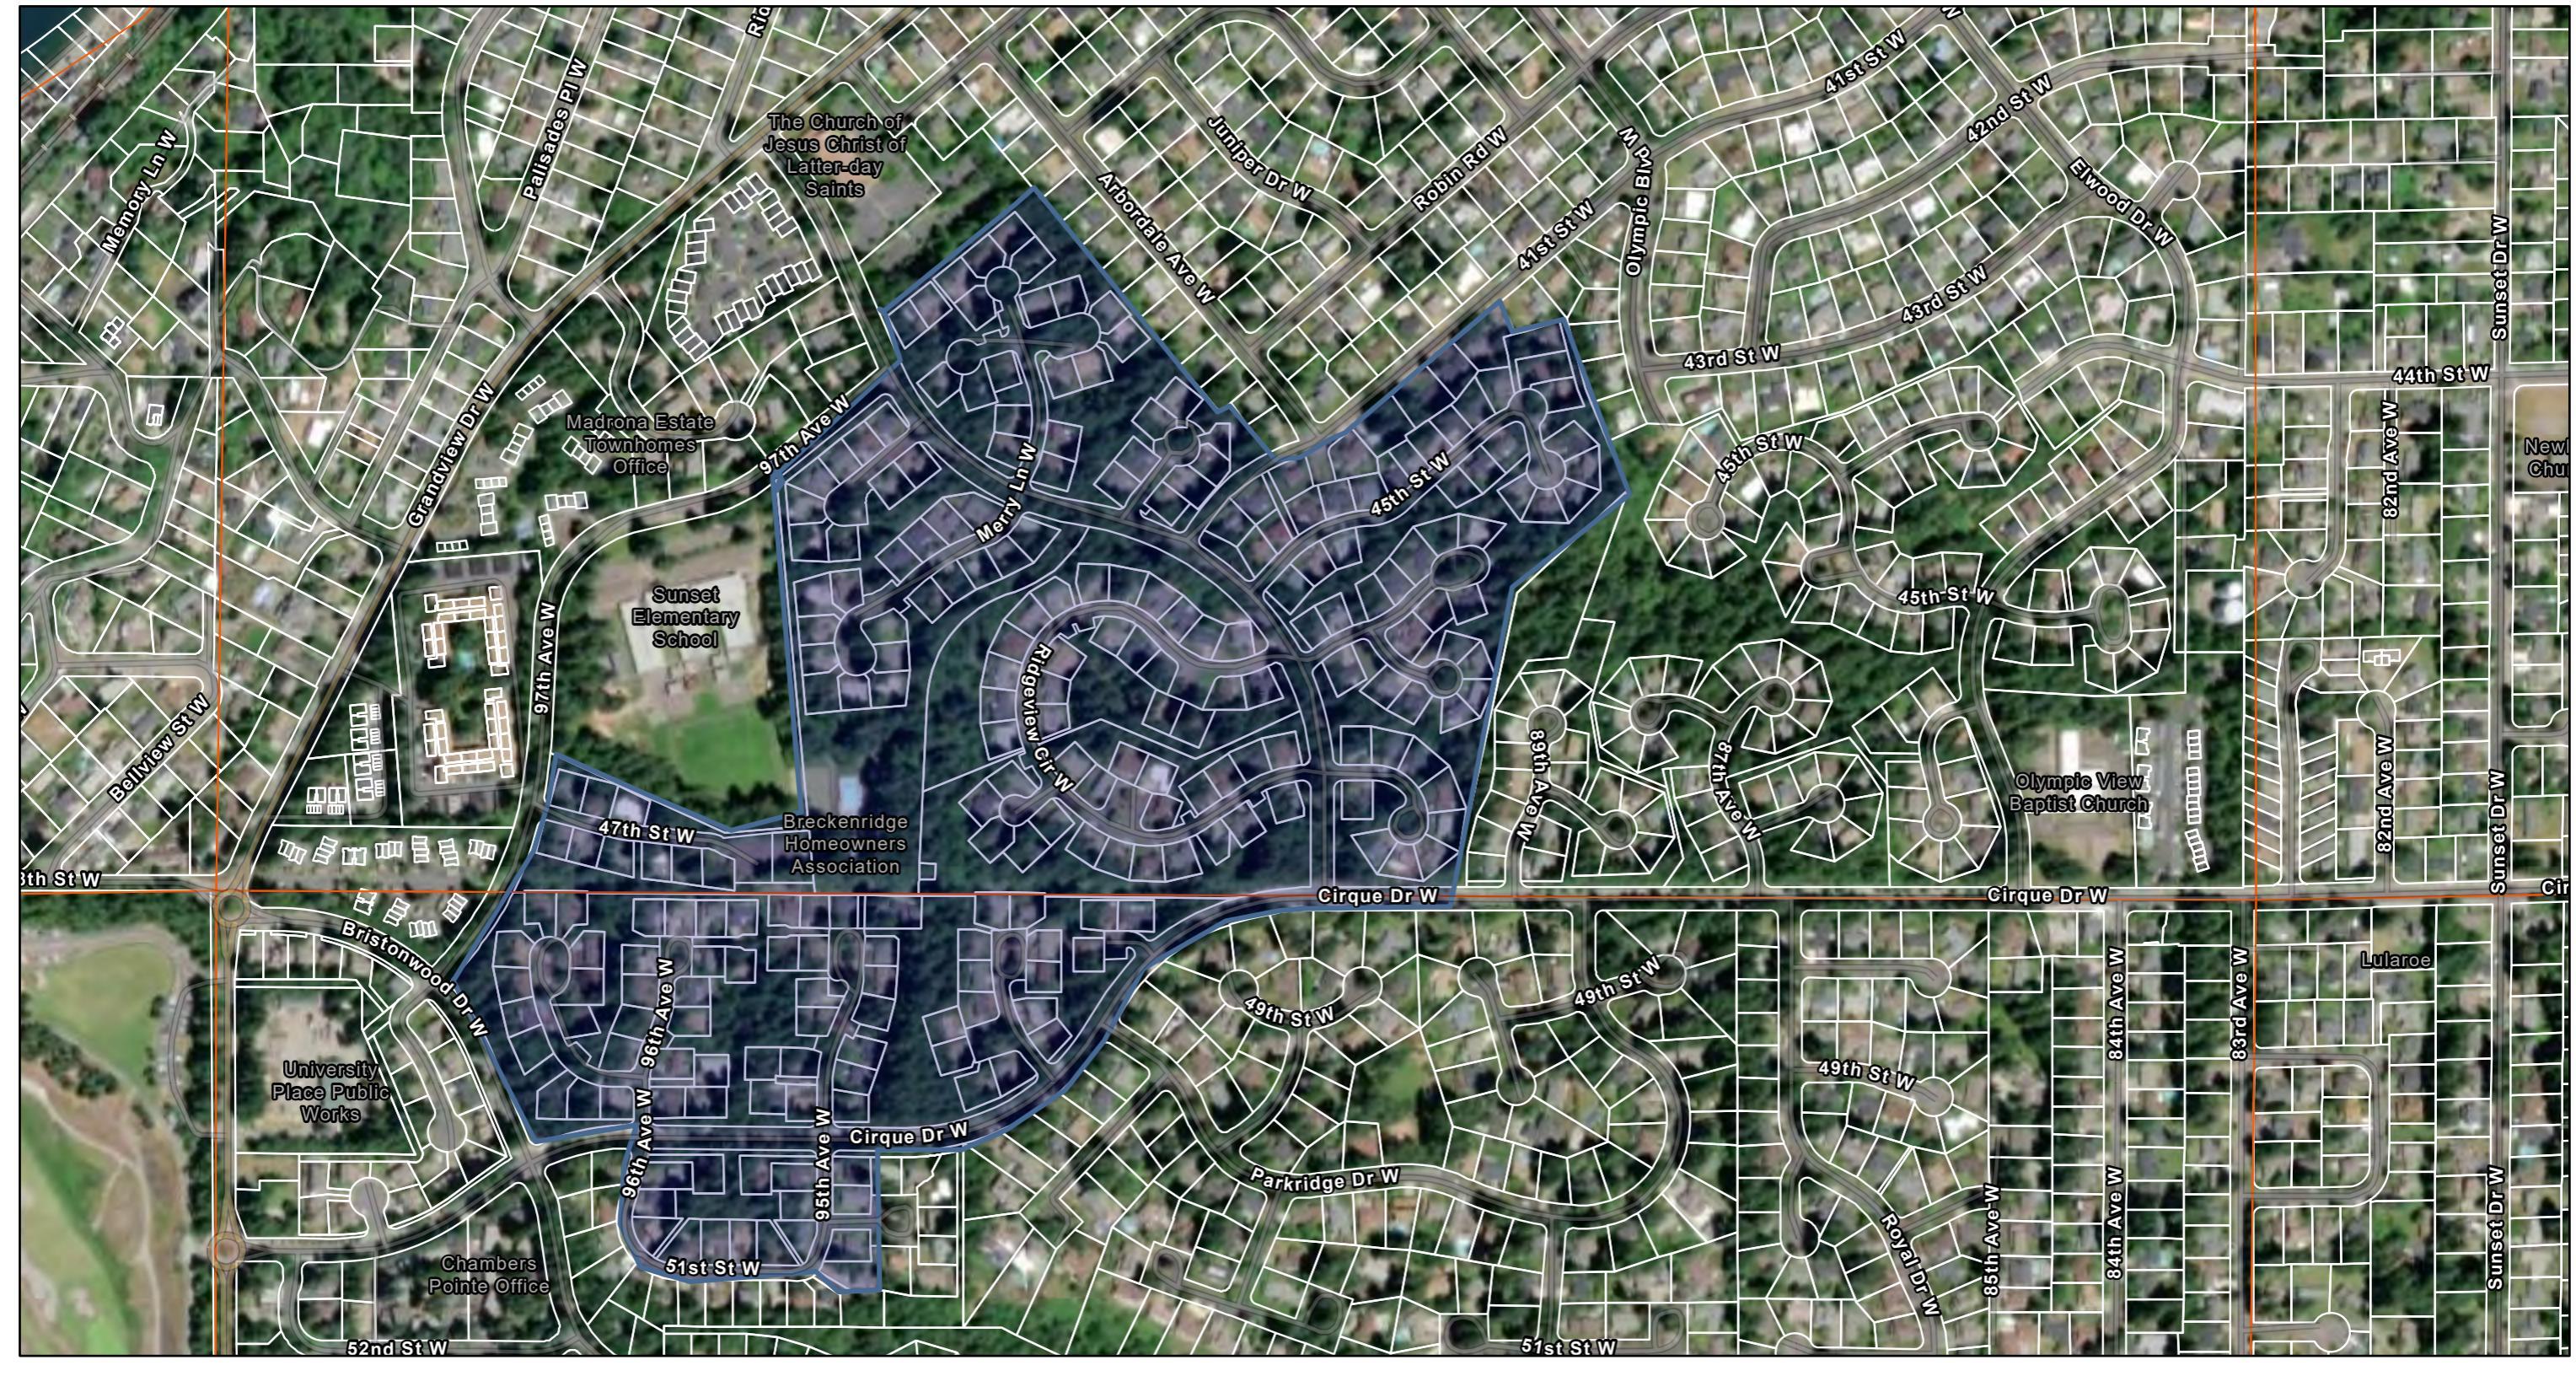
# Appendix 2 ArcGIS Web Map Beckonridge Tree Farm

# Beckonridge HOA Tagged Trees
